**St. Mary's Glacier Water and Sanitation District  
Wastewater Facilities Condition Assessment Memorandum**

Date: March 25, 2019

Subject: Wastewater Treatment Facility and Collection System Improvements Project Memorandum

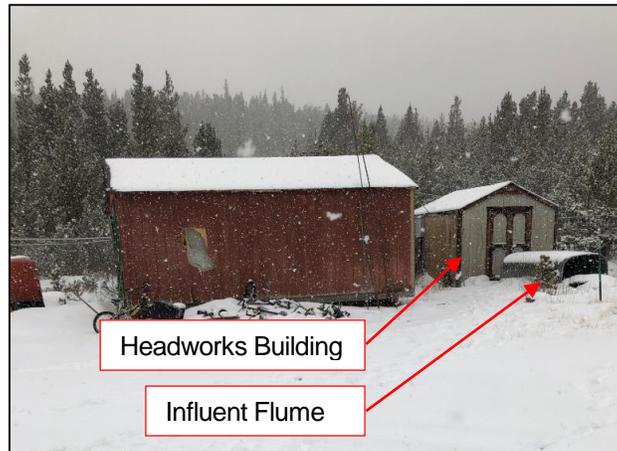
Figure 1: Headworks Facilities

The District's current WWTF headworks is located in the northwest corner of the site and consists of a Tuff Shed building and Quonset hut. The Tuff Shed building houses a perforated-plate manually cleaned influent screen and automatic composite sampler, and is used for storage. The Quonset hut shelters but does not fully enclose the palmer-bowlus flume which is used for influent flow monitoring. See Figure 2 for a photo of the existing headworks facilities.

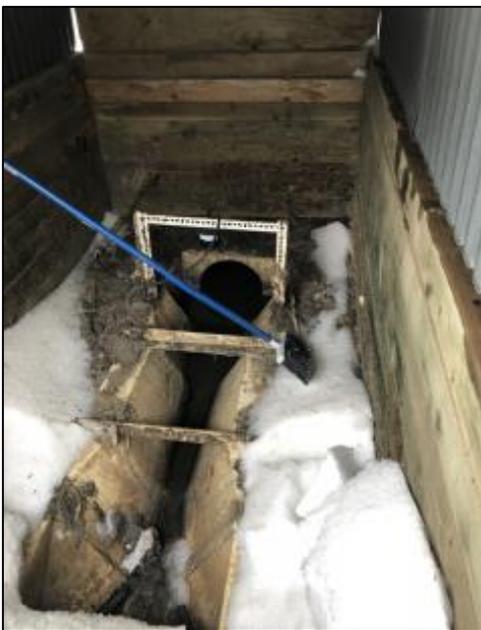
Figure 3: Influent Flume

- No ventilation is provided in the Tuff Shed building which is rated as a Class I, Division 2 space (see Figure 3).
  - Without proper ventilation, the building is an unsafe and dangerous working environment for operations and facilities staff to enter.

- Raw wastewater generates hydrogen sulfide. Most commonly known for its rotten egg smell, hydrogen sulfide is a dangerous gas that is life threatening with too much exposure. Hydrogen sulfide is also a major cause of corrosion in structures.

- The headworks building requires ventilation improvements at a minimum to provide a safe working environment.
- The perforated plate (see Figure 4) used as a headworks screen is not acceptable by CDPHE design criteria and as stated by Operations staff, the plate allows solids to pass into the aeration basins where they eventually clog the RAS/WAS pumps and require maintenance.

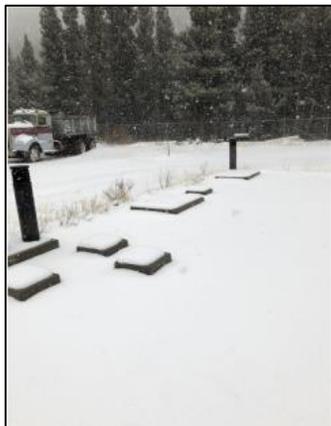
Figure 6: Aeration Basins

- The aeration basin structure is in good condition and there are no known structural issues.
- The air piping and diffusers are presumed to be original equipment.
  - Per 2001 WWTF Record Drawings and specifications, the diffusers are 9-inch fine-bubble membrane disks, 36 disks per basin.

- In the first aeration basin, Operations staff believes there are broken diffusers because of tumbling wastewater and non-uniform flow through the basin.

- Operations staff does not know the current condition of the diffusers and when maintenance was last completed. IT is possible the equipment is original, approximately 18 years old.

- With original equipment and some known broken diffusers, it is recommended the diffusers at a minimum be replaced with fine bubble diffusers. Proper air diffusion will improve oxygen transfer in the wastewater and increase operation efficiencies.

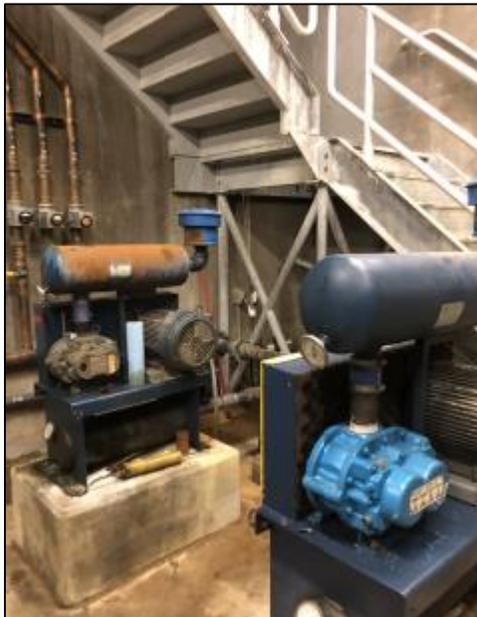
Figure 8: Aeration Blowers

- Per Operations staff, one of the blower motors has recently been replaced. The second blower motor requires constant maintenance and replacement soon due to the power issues at the site.

- Air piping from the blower equipment is corroded and aged. It is recommended the air piping be replaced and then coated to prevent corrosion.
- There are four air flow meters, one meter on the blower discharge header and one meter on each aeration basin lateral. Per the Operations staff, the meter on the discharge header does not work. None of the meters could not be read at the time of the visit. It is recommended all of these meters be replaced.

- Given the constant water level in the aeration basins, lower air pressure requirements, and the variable influent wastewater flows and strength (BOD<sub>5</sub>), the District may consider a change to centrifugal blowers. Centrifugal blowers may have greater initial capital costs than PD blowers, however they operate more efficiently over a wider operating range, are quieter, and are less maintenance intensive than PD's.

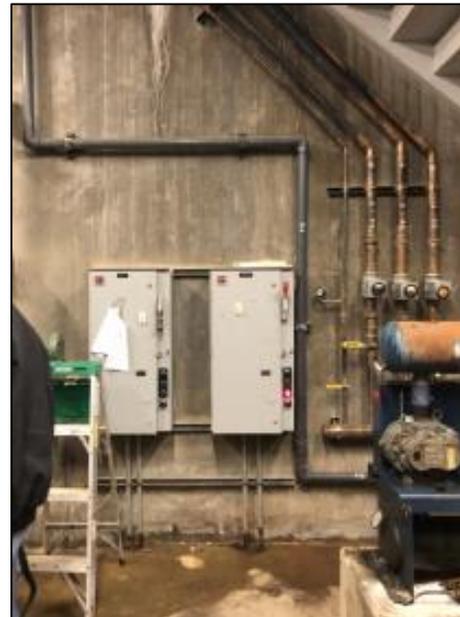
Figure 9: Aeration Controls

- The aeration system is operated manually at a constant speed. No dissolved oxygen (DO) or oxidation reduction potential (ORP) sensors are installed in the aeration basins to monitor oxygen concentrations or the oxidizing or reducing tendencies of the wastewater. Without these sensors or blower VFD's, the aeration system is operating inefficiently.

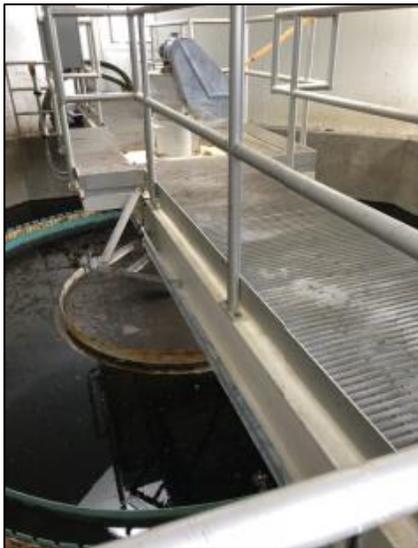
Figure 10: Secondary Clarifier

- The surrounding room is wood-paneled which is concerning given the clarifier generates a high-humidity environment. However, the current wood-paneled is painted and seems to be in relatively fair condition.

- The clarifier, by design, has a flat bottom. Solids are collected by a rotating mechanical vacuum arm connected to the RAS/WAS system.
  - Operations staff indicated their intent to drain the clarifier this spring to assess the condition of existing clarifier equipment. However, given the age of the equipment, lack of surface skimmer, and uneven weir installation, Lamp Rynearson recommends replacement of the clarifier components, addition of a surface skimmer, and leveling of the existing weirs.

- Replace clarifier equipment, adjust weirs for improved operation, and add skimmer for automatic scum removal;
- Provide storage space in the building addition to accommodate the District's hydro-jetter and spare parts;

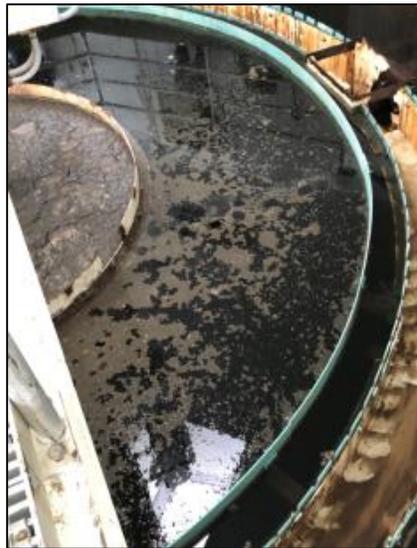
Figure 11: Secondary Clarifier Weir

- The overflow weirs at the clarifier circumference are not level, however appear in good condition.
  - There is currently no automated mechanical skimmer to remove scum collecting on the water surface of the clarifier. Operations staff manually collects surface scum.

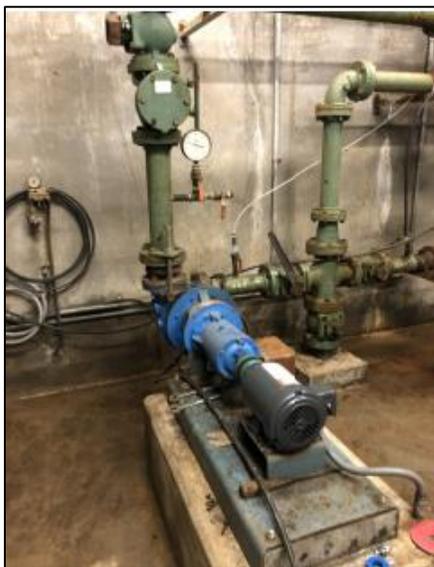
Figure 13: RAS Pump

- In normal operating conditions, the pumps are constantly returning solids from the clarifier to the aeration basins.
- The RAS/WAS pumps were observed to be in fair condition.

- One pump motor had recently been replaced and was running smoothly.
  - The other pump is scheduled to be replaced in 2019 as part of the Operation staff's routine maintenance.

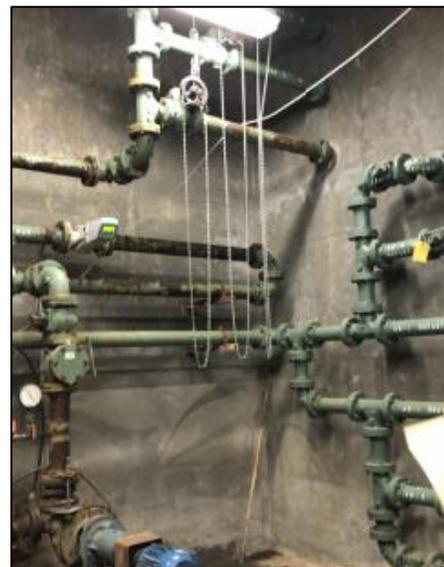
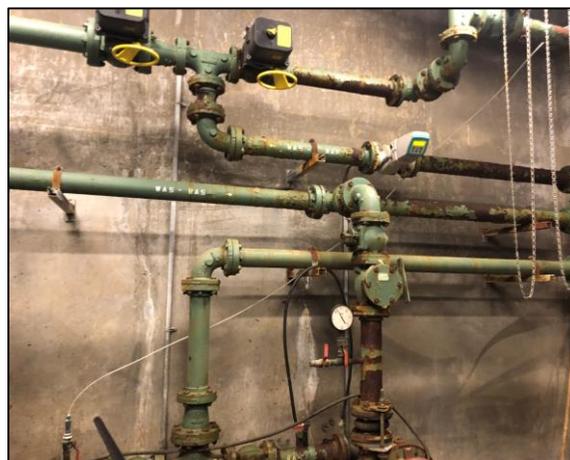
- At the time of the site assessment, the RAS flow was approximately 97 gpm.
- The piping gallery above the pumps is in poor condition with many corroded pipes and valves.

- It is recommended that a majority of the piping be replaced and then coated to prevent corrosion.
  - The motorized plug valves appear in good condition and do not require replacement.

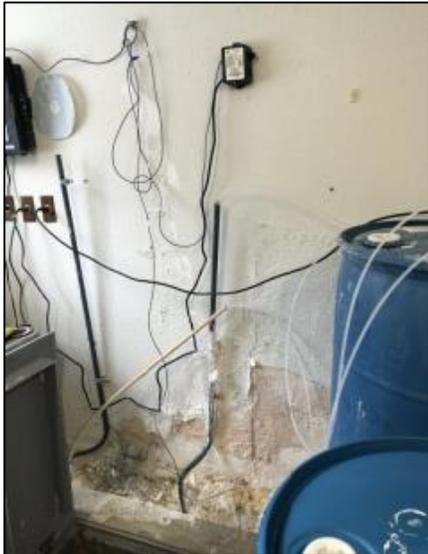
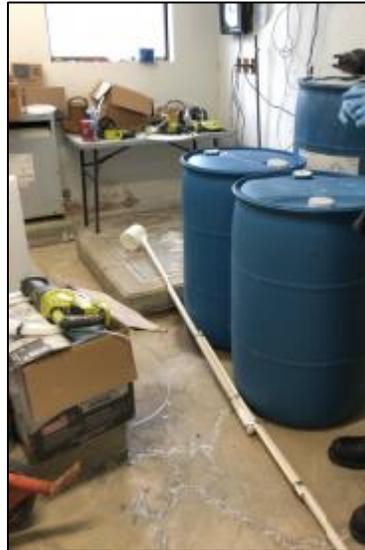
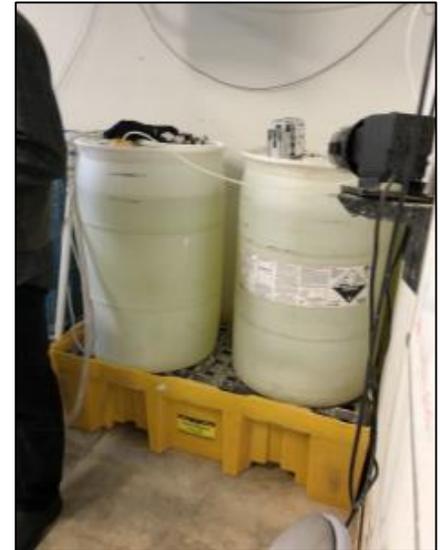
- Per Operations staff, chemical within the chemical feed tubing often freezes and shuts down the system, thereby failing to disinfect the waste stream.

- For the amount of chemical stored, there is inadequate secondary containment per OSHA standards.
- The chemical feed room is equipped with a unit heater, however lacks proper heating, ventilation, and air conditioning.

- Chemicals are also stored in the facility's restroom. The restroom is currently coupled as a laboratory for sample preparations. This small, poorly ventilated space is not intended to be used as a laboratory and presents safety hazards.

- Lamp Rynearson recommends that the chemical feed and storage be relocated to a new room with proper secondary containment and HVAC. Per discussion with Operations staff during the site visit and given the limited space within the existing building, the new chemical feed and storage room is likely located within a building addition. Relocating the chemicals will also protect the existing electrical equipment and provide space for proper storage and relocation of the facility's laboratory outside of the bathroom. The existing bathroom and office could remain in place.

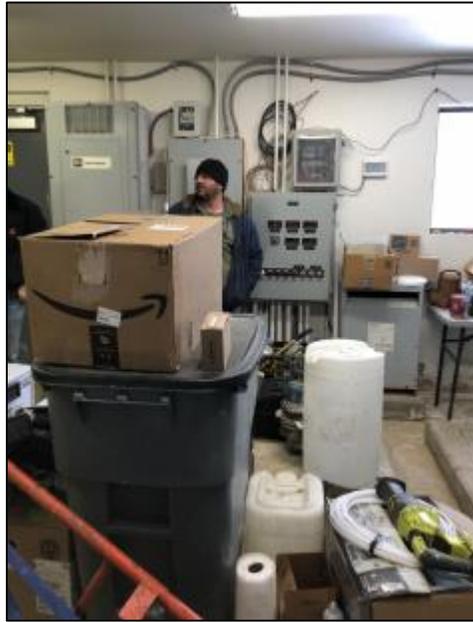
Figure 19: Electrical Panels

Panel PP-1 being in the same room as stored chemicals without proper ventilation is being exposed to a corrosive environment. This is evident in the panel's corroded box and piping. See the figure below.

The electrical panel should be replaced and the chemical feed equipment and storage should be relocated to a separate room with proper ventilation. Additionally, it was observed that equipment is being stored within two feet of Panel PP-1, which is in violation of both electrical and fire codes. Direct access to Panel PP-1 should be provided with a minimum of two-foot separation between the face of the panel and anything that could obstruct the panel opening.

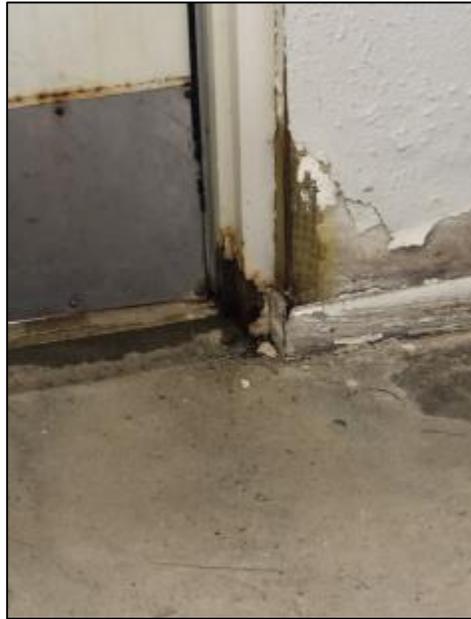
Figure 20: Door Corrosion

- The door frame on the west side of the building is not weathertight and allows air and water to seep into the process building and drain into the basement. This door and door frame should be replaced, as shown in Figure 20.
