**St. Mary's Glacier Water and Sanitation District  
Wastewater Facilities Condition Assessment Memorandum**

Date: March 25, 2019

Subject: Wastewater Treatment Facility and Collection System Improvements Project Memorandum

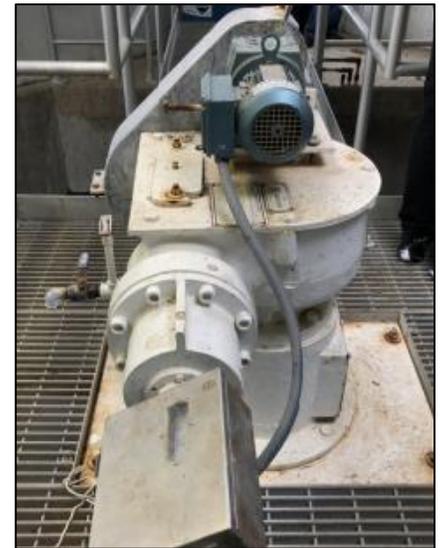
Figure 12: Secondary Clarifier Drive

- The overflow weirs at the clarifier circumference are not level, however appear in good condition.
  - There is currently no automated mechanical skimmer to remove scum collecting on the water surface of the clarifier. Operations staff manually collects surface scum.

- The clarifier, by design, has a flat bottom. Solids are collected by a rotating mechanical vacuum arm connected to the RAS/WAS system.
  - Operations staff indicated their intent to drain the clarifier this spring to assess the condition of existing clarifier equipment. However, given the age of the equipment, lack of surface skimmer, and uneven weir installation, Lamp Rynearson recommends replacement of the clarifier components, addition of a surface skimmer, and leveling of the existing weirs.
